PAVED SHOULDER PROBLEM - STEVENSON EXPRESSWAY

A Phase of
Research Project IHR-6
Condition Survey of Route U.S. 66

July 1967

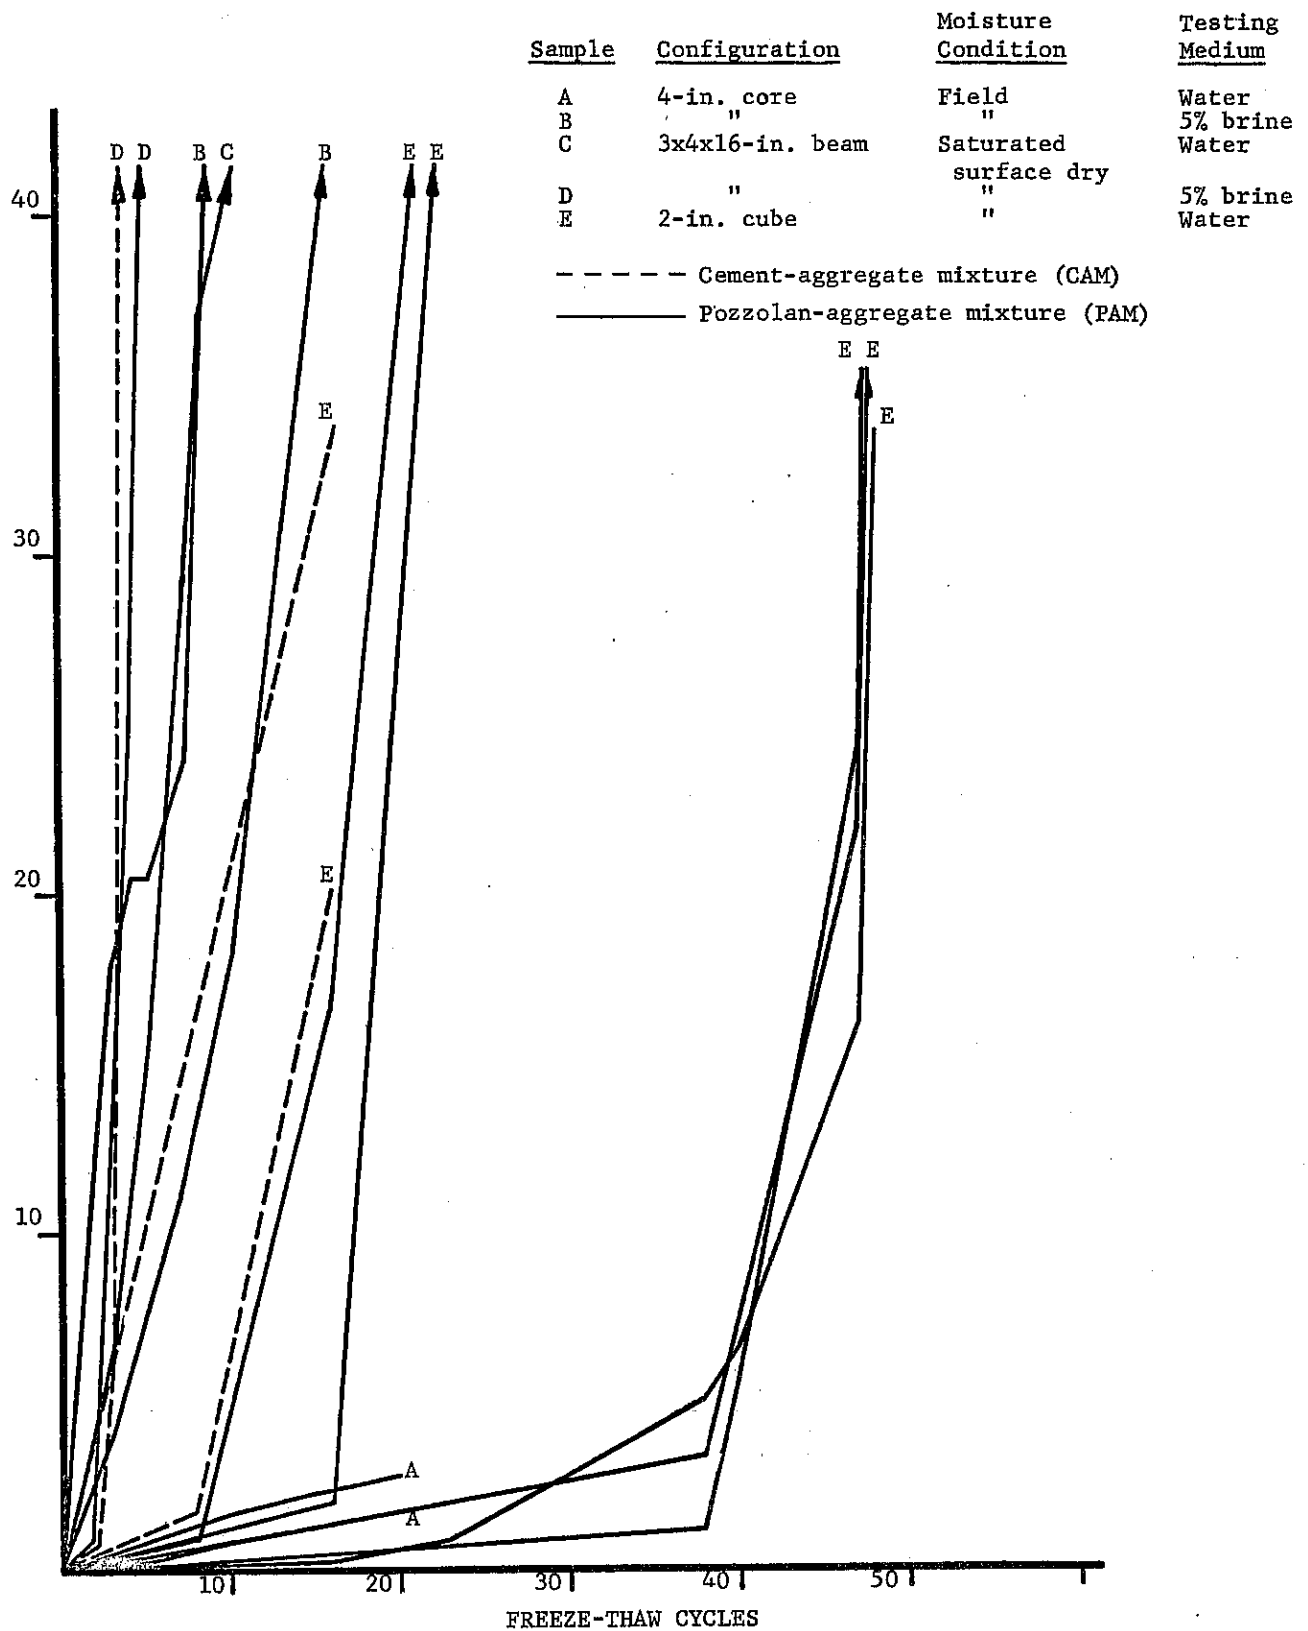
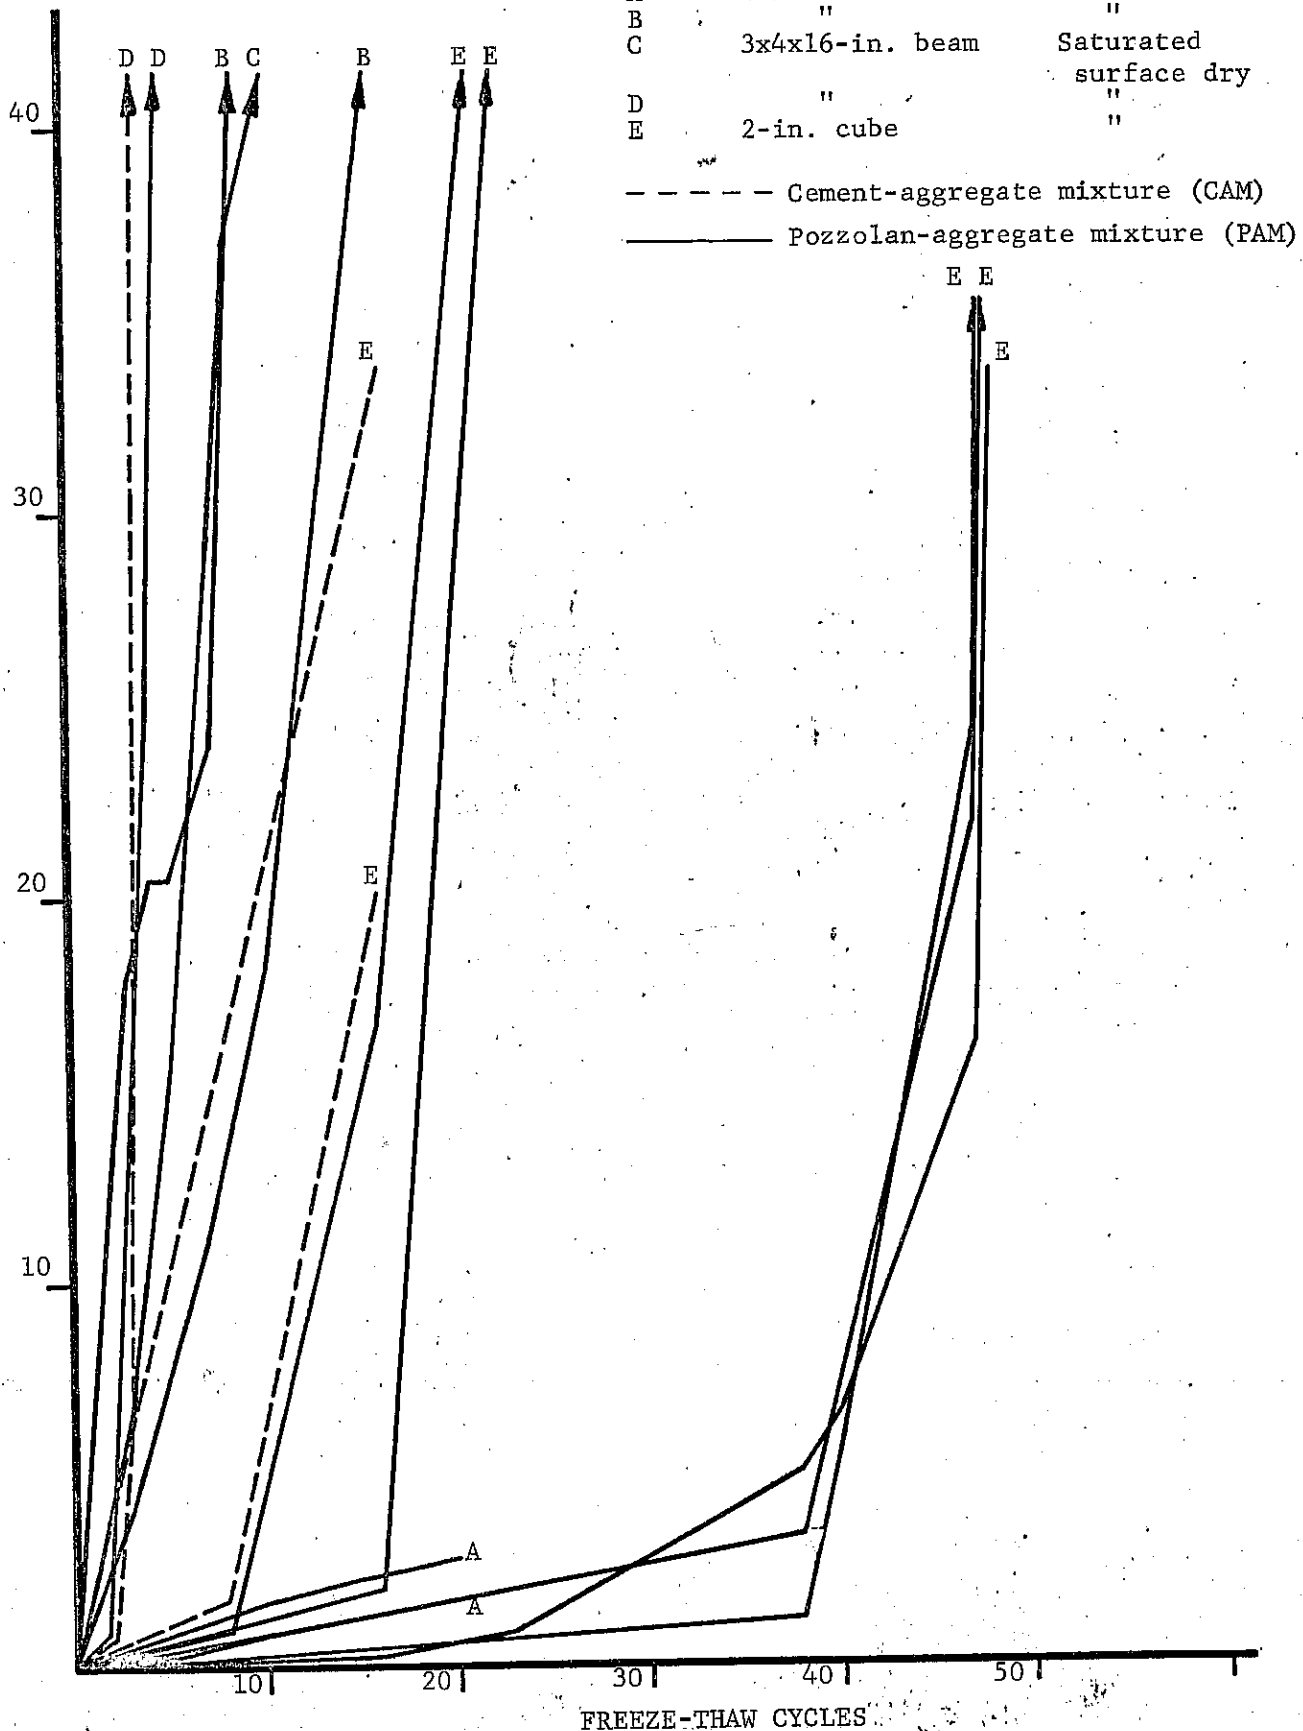
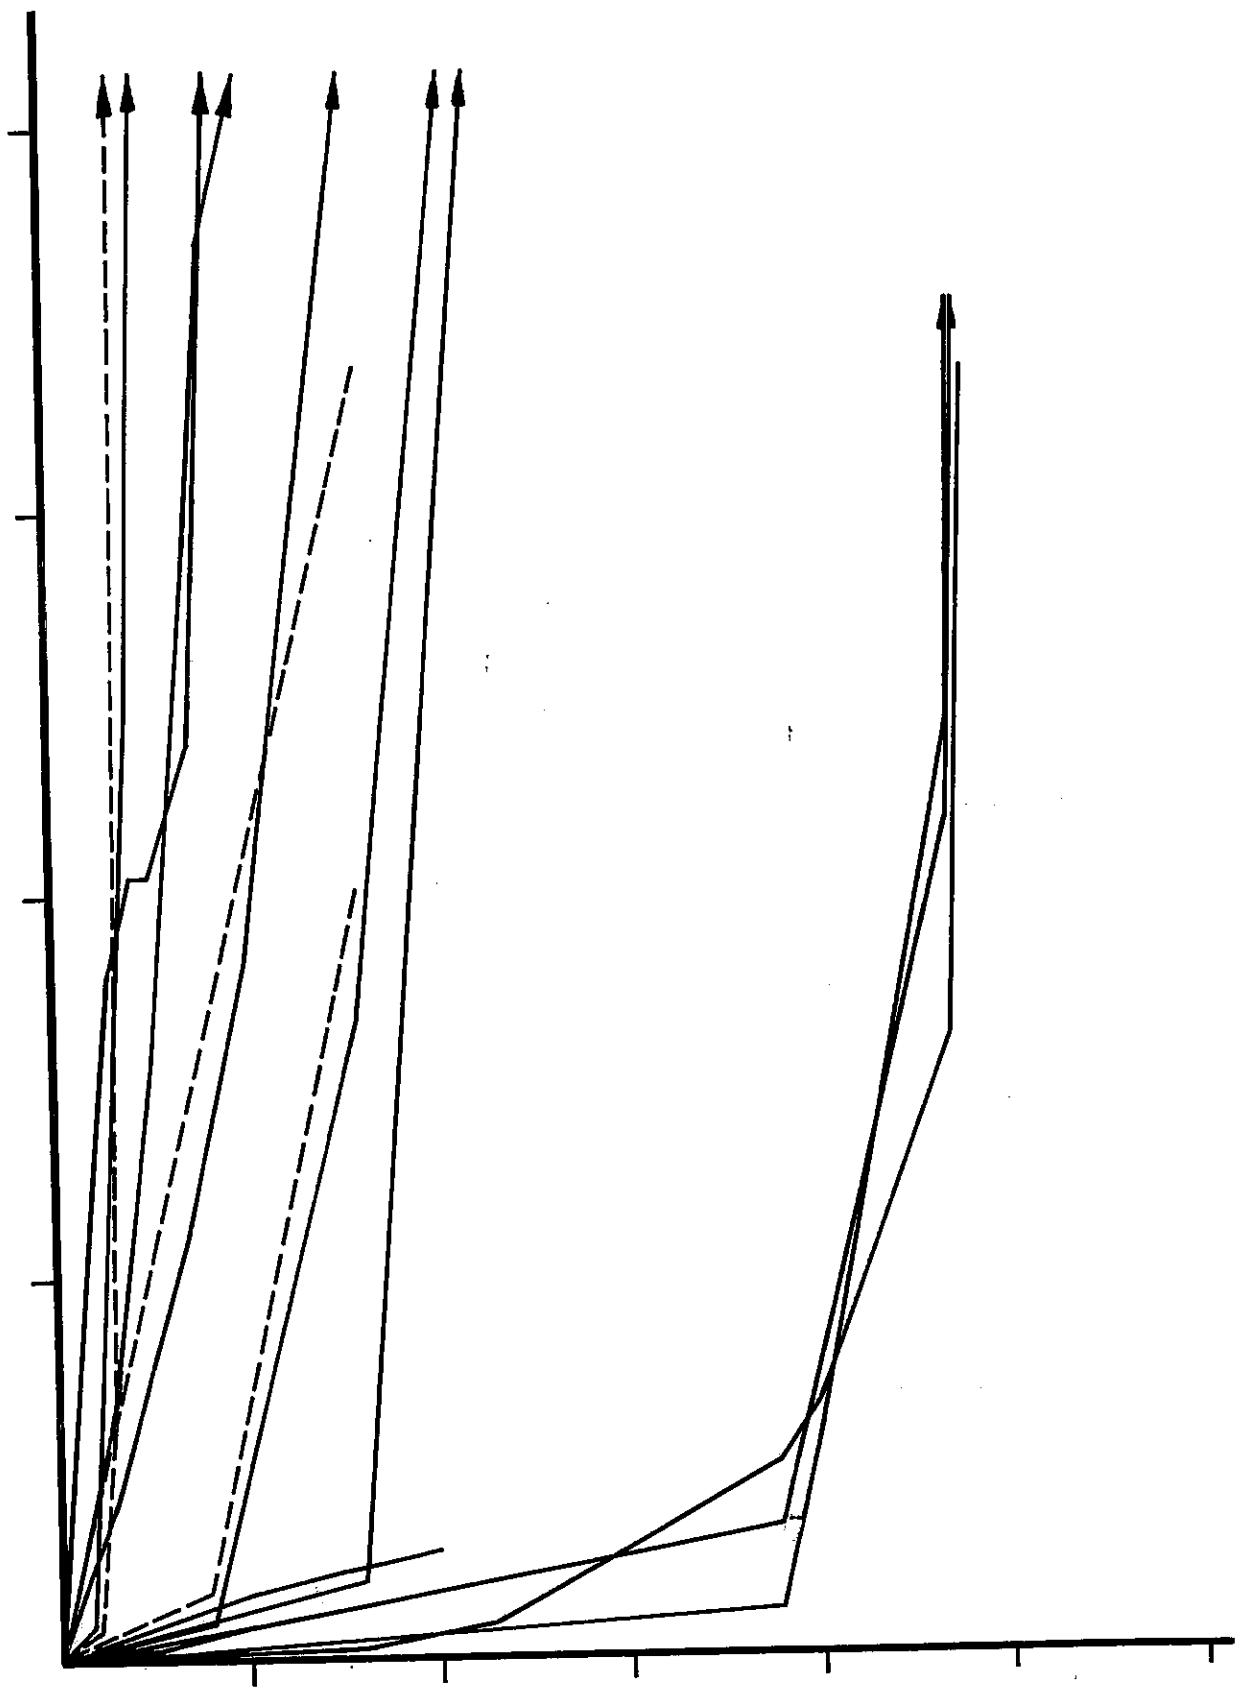
Figure 8. Results of freeze-thaw tests of field samples of cemented CAM and PAM.

It will be noted in Figure 8 that the brine testing condition was far more severe than the standard water condition, and that specimens tested in brine failed in a very few cycles of testing. Several specimens will be seen to have performed quite well when tested in ordinary water.

The results of tests of additional samples in which brine was used as the testing medium have not been included in Figure 8 but showed similar results.
